Manhole Inspection Summary

Manhole # S39Y1_038MH

Insp Date: **4/9/08 12:23 PM**

Location Address: **337 Washburn Ave.**

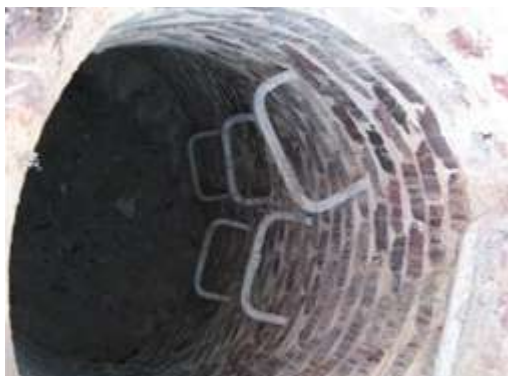
Steps

Count: **6** Missing: **0** ☒ **Corroded**

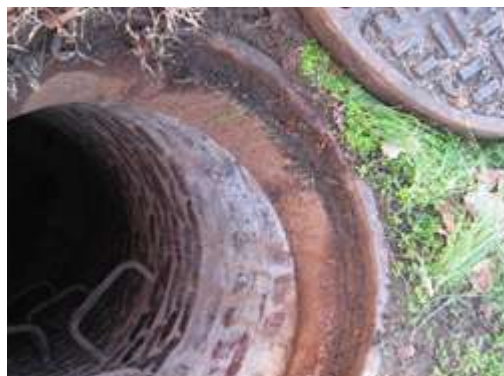
Defect 2

Infiltration: ☐ None ☐ Joint ☐ Cracks ☐ Mortar ☐ Roots ☒ **Wall**

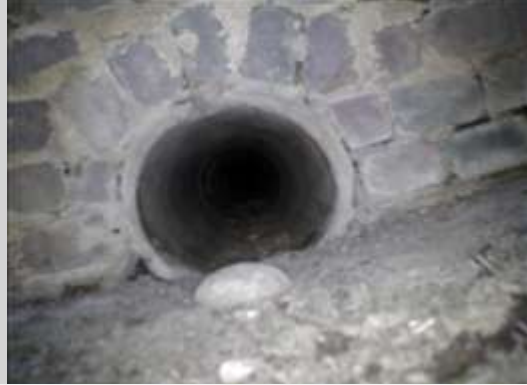
12 O'Clock Outflow

8 in. Circular Gravity Sewer
Pipe Out @ 12 O'Clock

Pipe Height: **10.8** (in.) Rod and Bar (Angled)

Pipe Material: **Clay** ☐ Pipe Lined

Invert Depth: **9.26** (ft.) Flow Characteristics: **None**

Infiltration: **None** Pipe Seal Cond: **Sound**
